#17-NA-025: Repeated Radio/display Resets, Volume Control Inoperative, Waiting for Update Media Message, Voice Command For Calling Bluetooth Phone Contacts Inoperative, Service Rear Vision System Message, Radio Turns On Unwanted At Startup, and/or Navigation Radio Destination State Defaults To WV - (Jan 31, 2017)

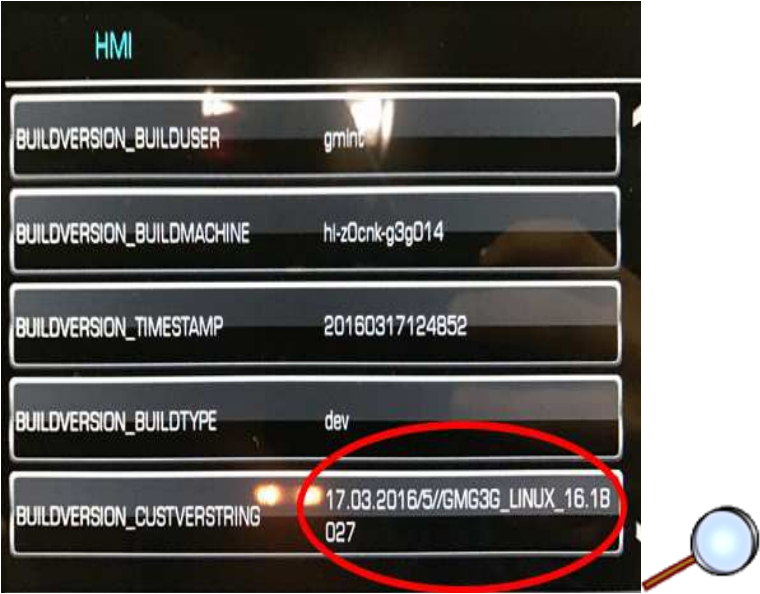
Once in Development Screen press HMI and document the Buildversion-Custverstring

If the software is one of the following, reprogram the Human Machine Interface Control Module. Refer to *Human Machine Interface Control Module Programming and Setup* in SI.

- 2016 Models - 15.1A044
- 2016 Models - 15.1A052
- 2016 Models - 15.2B033
- 2017 Models - 16.1B027
