#17-NA-025: Repeated Radio/display Resets, Volume Control Inoperative, Waiting for Update Media Message, Voice Command For Calling Bluetooth Phone Contacts Inoperative, Service Rear Vision System Message, Radio Turns On Unwanted At Startup, and/or Navigation Radio Destination State Defaults To WV - (Jan 31, 2017)

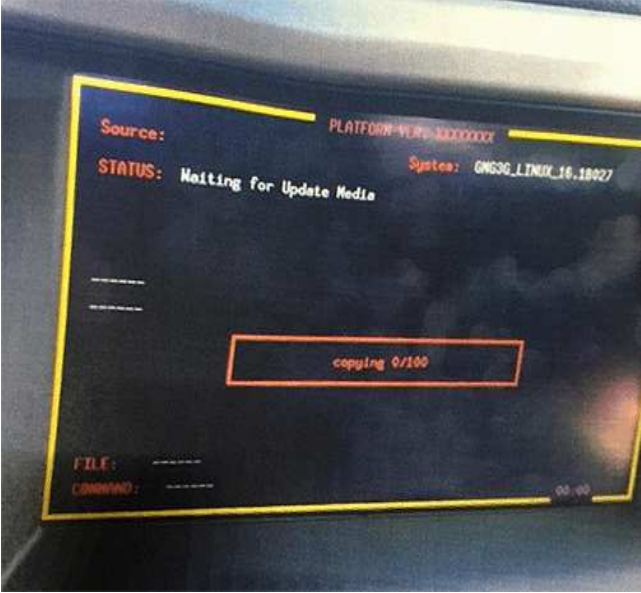
| Condition | <div>Some customers may comment on one or more of the following conditions:</div> <div></div> <div><ul style="list-style-type: none"><li>• Random Infotainment system display resets while driving, screen temporarily goes blank and then returns after approximately 5 seconds.</li><li>• The “waiting for update media” screen appears/appeared while driving and may disappear after 80 minutes.</li><li>• The volume knob or slider bar (Cadillac) will not function.</li><li>• Momentary black screens at startup.</li></ul></div> |

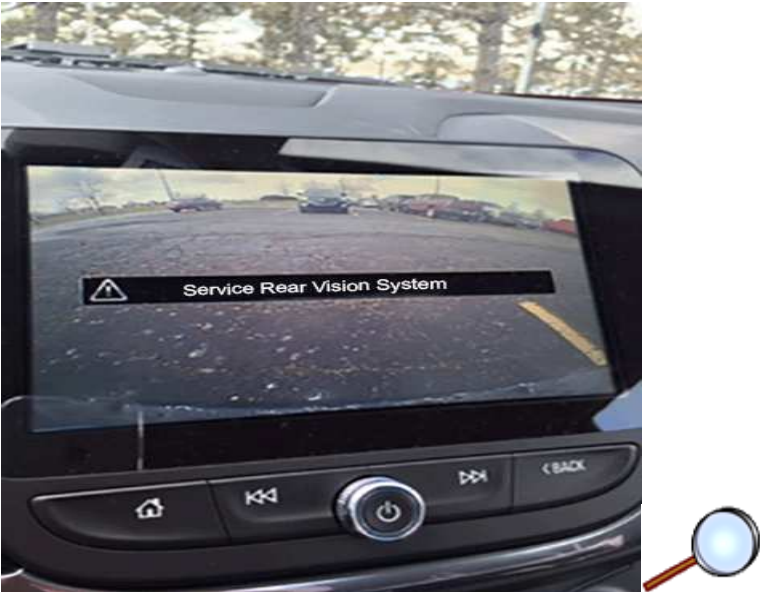
| | <ul style="list-style-type: none"><li>• Voice recognition inoperative for Calling Bluetooth Phone Contacts.</li><li>• The HVAC controls function but will not show on the main display.</li><li>• Seek buttons on the front controls will not function.</li><li>• XM only shows radio ID. Station List is blank.</li><li>• Radio will shut off and when restarting the vehicle the radio will turn on unwanted.</li></ul> <div data-bbox="711 307 1435 870"></div> <ul style="list-style-type: none"><li>• Service Rear Vision System Message displayed.</li><li>• When entering an address using the touch screen the state selection defaults to West Virginia (WV) instead of Virginia (VA).</li></ul> <p><b>Note:</b> This software update also includes CarPlay and Android Auto Improvements.</p> |
